INSPECTION BULLETIN

ARI 300 Underframe Structural Inspection

The information contained in this Inspection Bulletin is a fundamental explanation of the inspection and acceptance criteria for the structural integrity of the ARI style 300 stub sill underframe as specified in 49 CFR Part 180, Subpart F, (SP 12095).

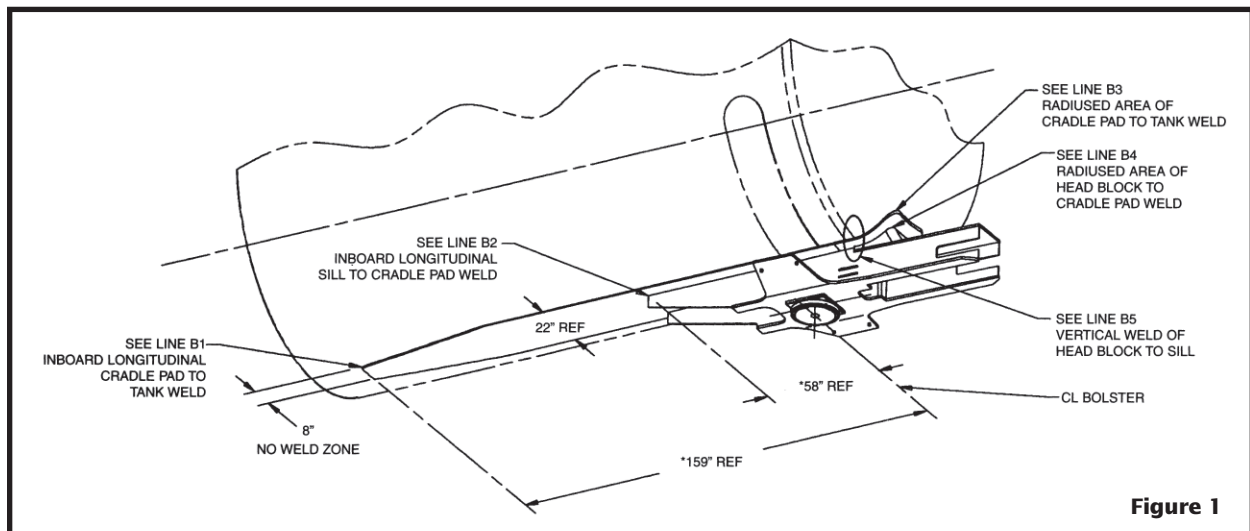
OVERVIEW OF THE ARI STYLE 300 UNDERFRAME

B. Inspect the structural tank attachment welds for cold-rolled terminations, cracks, undercuts and all other defects. The dimensions referenced in **Figure 1** may be used as guidelines when cutting inspection ports on jacketed cars.

1. Visually inspect, from the tank exterior, the last 3” of the inboard longitudinal fillet weld of the cradle pad to tank, (B1). Inspect adjacent cradle pad and tank parent metals (4 places per car).
See Figure 1.

2. Visually inspect, from the tank exterior, the last 3” of the inboard longitudinal fillet weld of the sill web to cradle pad, (B2). Inspect adjacent sill web and cradle pad parent metals (4 places per car). **See Figure 1.**

3. Visually inspect, from the tank exterior, the radiused area of the outboard cradle pad (head pad) to tank head fillet weld, (B3). Inspect adjacent cradle pad and tank parent metals (4 places per car). **See Figure 1.**

4. Visually inspect, from the tank exterior, the radiused area of the outboard head block to cradle pad (head pad) fillet weld, (B4). Inspect adjacent head block and cradle pad parent metals (4 places per car). **See Figure 1.**

5. Visually inspect, from the tank exterior, the vertical groove weld, which attaches the head block to the sill web, (B5). Weld length is approximately 1” long. Inspect adjacent head block and sill web parent metals (4 places per car). **See Figure 1.**

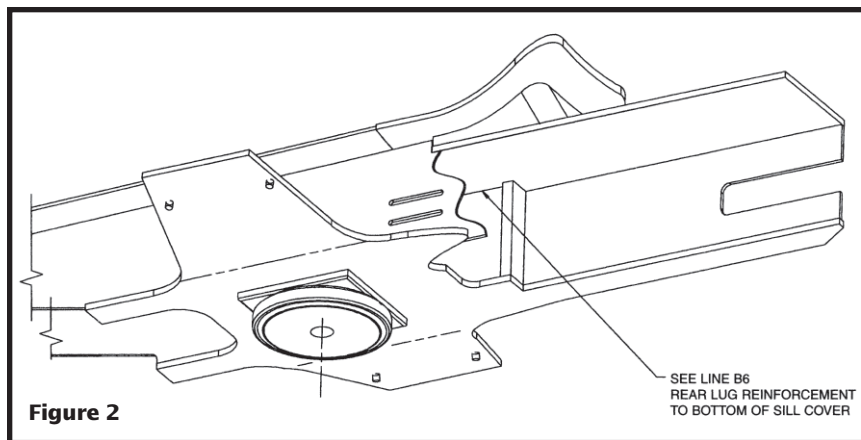
OVERVIEW OF “OUTBOARD” WELD AREA ARI STYLE 300 UNDERFRAME

6. Visually inspect, from the tank exterior, the longitudinal rear lug reinforcement to the bottom of the sill top cover fillet weld, (B6). Inspect adjacent rear lug reinforcement and sill top cover parent metals (4 places per car). **See Figure 2.**
