INSPECTION BULLETIN

Side Sill Closure Inspection and Repair

This inspection Bulletin provides details for the inspection and modification of side sill closure plates on ACF built Center Flow® covered hopper cars. The closure plate may be referred to as the pistol plate, or hair pin closure.

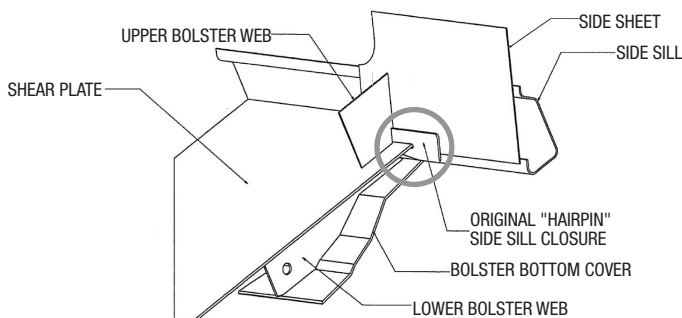
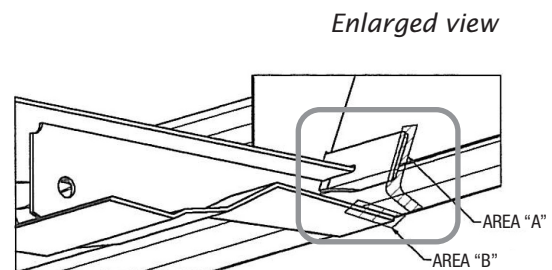
The side sill closure plate was utilized from 1978 – 2005. The areas shown below should be inspected for discontinuities in the form of cracks emanating from the welds at the inboard end of the closure plate attachment to the side sheet and at the bolster bottom cover attachment to the side sill. In all cases, replacement with a new closure plate is recommended at all four corners.

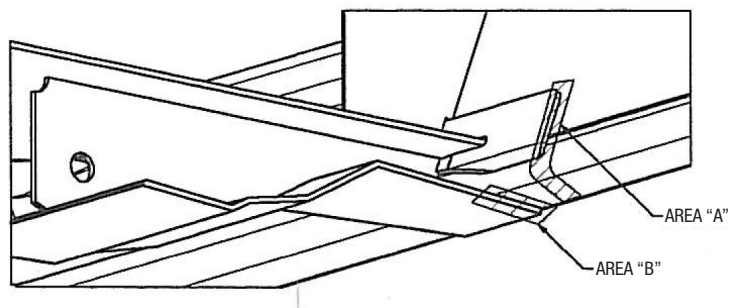
Cracks emanating from the welds can propagate up into the side sheet and down to the inside radius of the side sill and outward along the bottom of the side sill.

- Remove all dirt and debris from Areas "A" and "B" by wire brushing.
- Dye-penetrant inspect these areas.
- If no cracking is found proceed with replacement of the side sill closure plate (recommended), or return the car to service. If the car is returned to service without replacement of the closure plate a plan should be implemented to inspect this area on a routine basis.

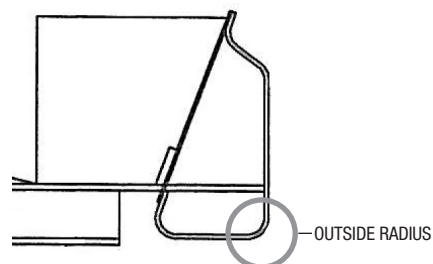
- A crack that splits and branches in multiple directions
- Two or more cracks within 3" of one another
- A crack that is open 1/32" or greater
- A crack that propagates into the outside radius of the side sill, see below.

Critical Note: If any of the following special conditions are observed it will be necessary to replace a section of the side sill. See "Side Sill Section Replacement."

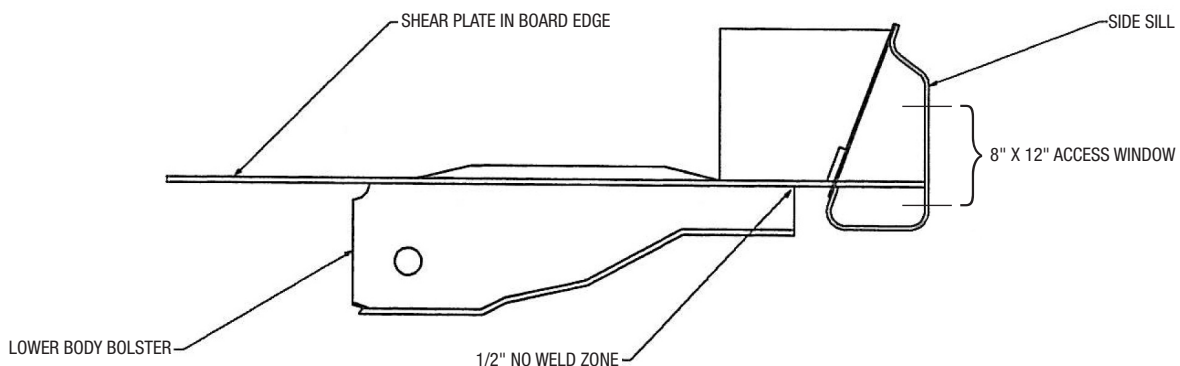
Side Sill Inspection & Repair Procedures

- With the closure plate removed, dye-penetrant inspect area "A."

- Side sill cracks must be repaired from both sides.
- Access to the interior of the side sill is gained by cutting a window, 8" vertical x 12" horizontal, in the outside vertical flat of the sill. Radius the corners to 2" minimum. Save the cutout scrape to seal the access window when the repair is completed.

- The outboard edge of the opening must be 1-1/2" from the inboard edge of the shear plate.
- Beginning inside the sill, remove the crack by air arcing the affected area plus 1/2" beyond the crack length to a depth of 1/4". Prepare the area for welding.

- Weld the area using E7018 electrodes or equivalent wire. Weld first pass stringer and weave the remaining passes.
- Prepare the outside surface with air arc to a depth that will ensure a 100% weld penetration in weld. Prepare the area for welding.

- Weld the area using E7018 electrodes or equivalent wire. Weld first pass stringer and weave the remaining passes.
- Close the access window by preparing the edges of the sill opening and the saved panel.

- Apply 1/8" x 2" wide back-up strips inside window opening.
- Replace the panel section and weld with E7018 electrodes or equivalent wire ensuring 100% penetration.
