INSPECTION BULLETIN

ARI 300 Underframe Structural Inspection

The information contained in this Inspection Bulletin is a fundamental explanation of the inspection and acceptance criteria for the structural integrity of the ARI style 300 stub sill underframe as specified in 49 CFR Part 180, Subpart F, (SP 12095).

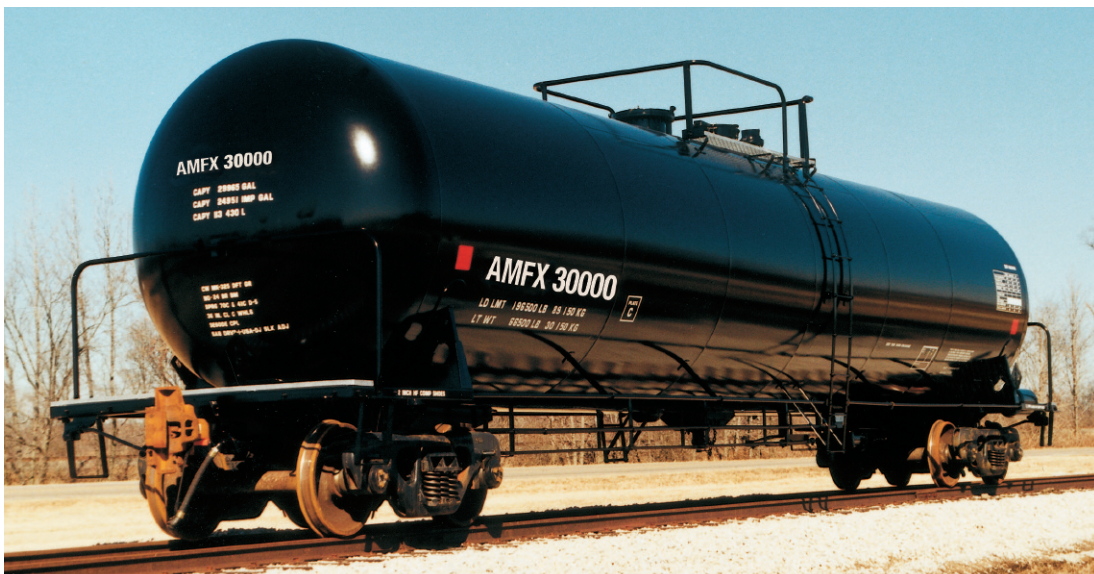
OVERVIEW OF THE ARI STYLE 300 UNDERFRAME

*This dimension may vary depending upon service conditions.
Contact ARI Product Engineering to verify stub sill termination dimensions.
Body bolster web omitted for clarity.

B. Inspect the structural tank attachment welds for cold-rolled terminations, cracks, undercuts and all other defects. The dimensions referenced in **Figure 1** may be used as guidelines when cutting inspection ports on jacketed cars.
